Situation Photo Log

Wednesday, March 14, 2012

Kalamazoo River / Enbridge Spill

Talmadge Creek To Confluence

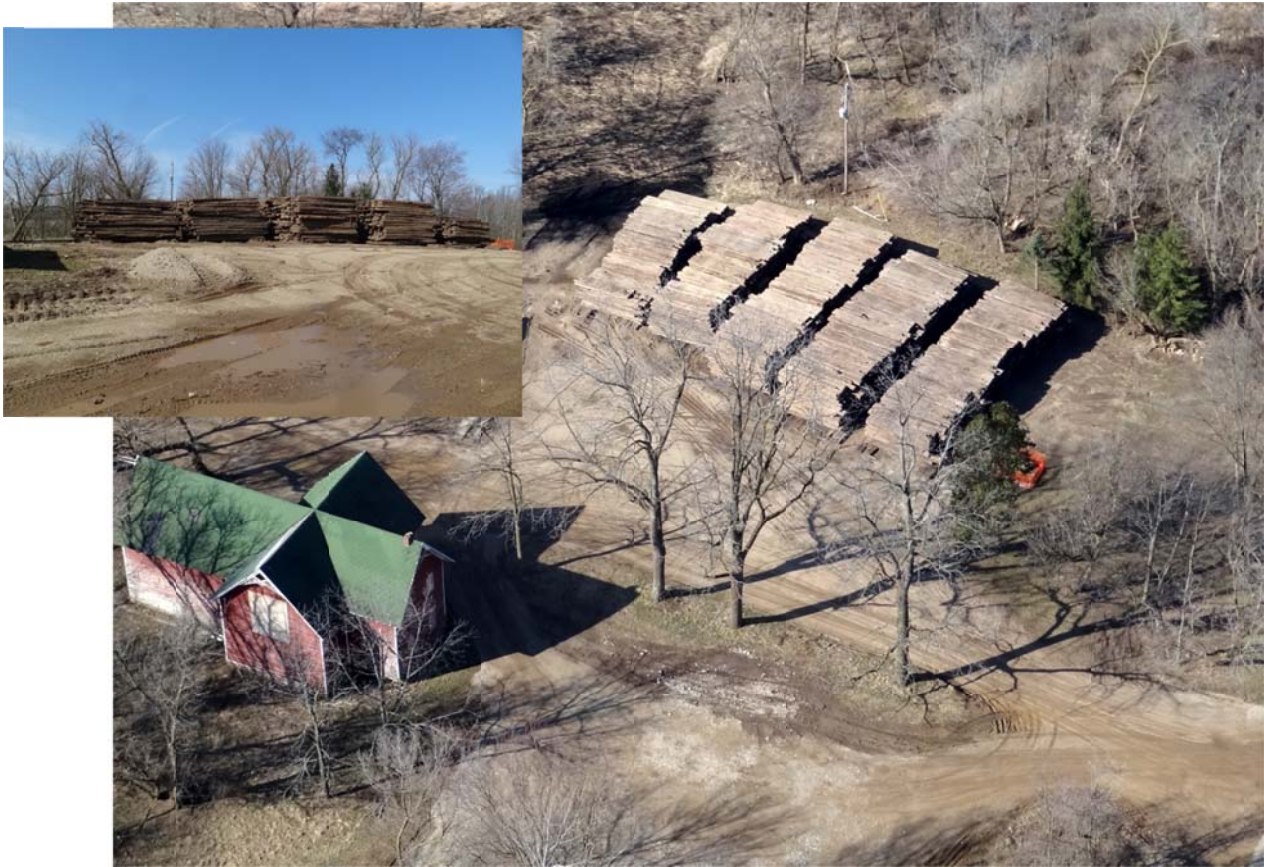
1. Timber mats staged at the farmhouse on Division Drive.

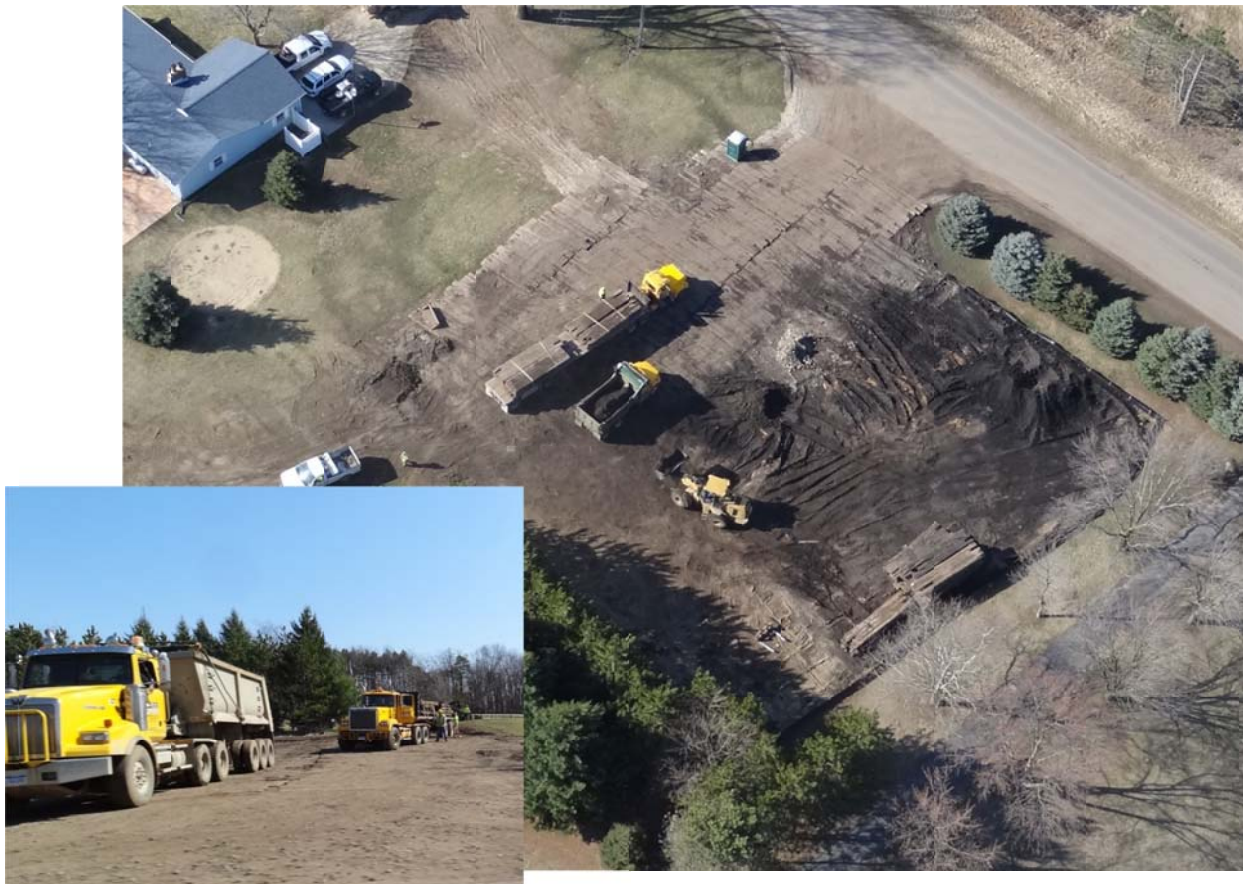
2. Crews loading up timber mats at house on 16 Mile Road.

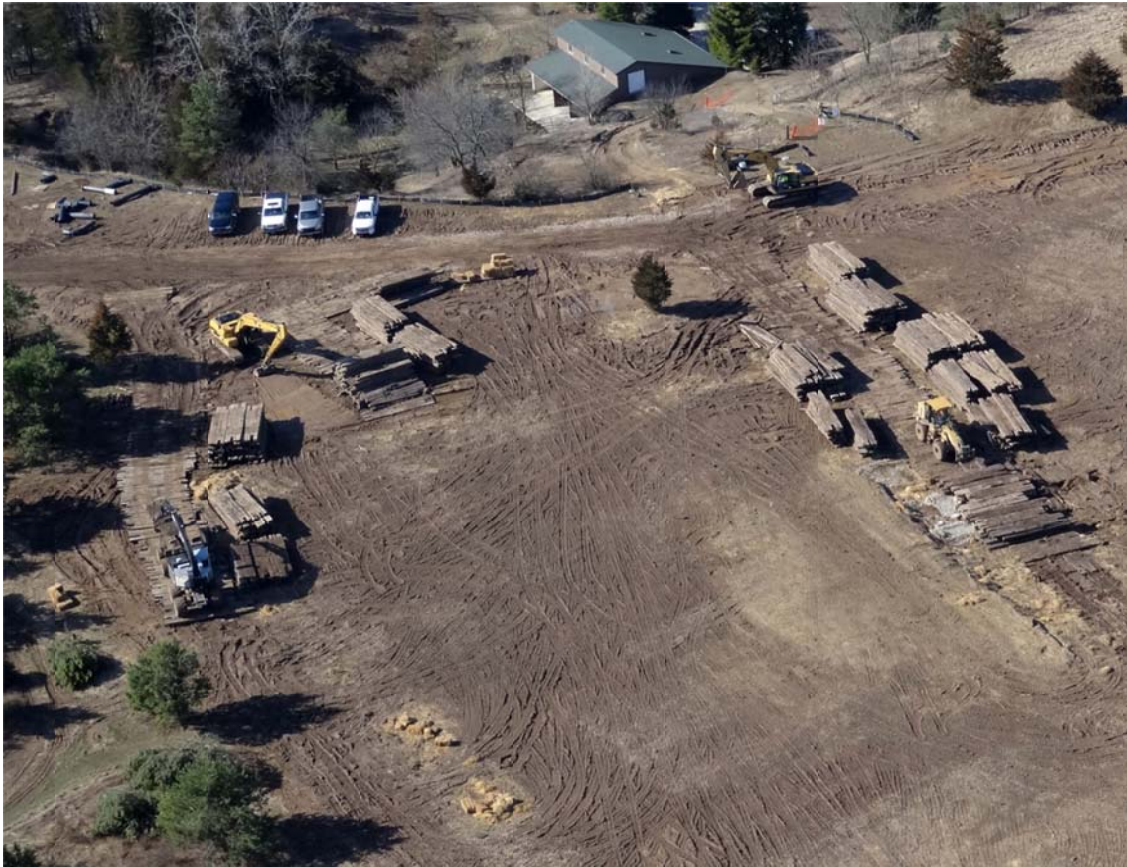
3. Former Turbidity Control Structure area, crews continue removal and staging of timber mats.

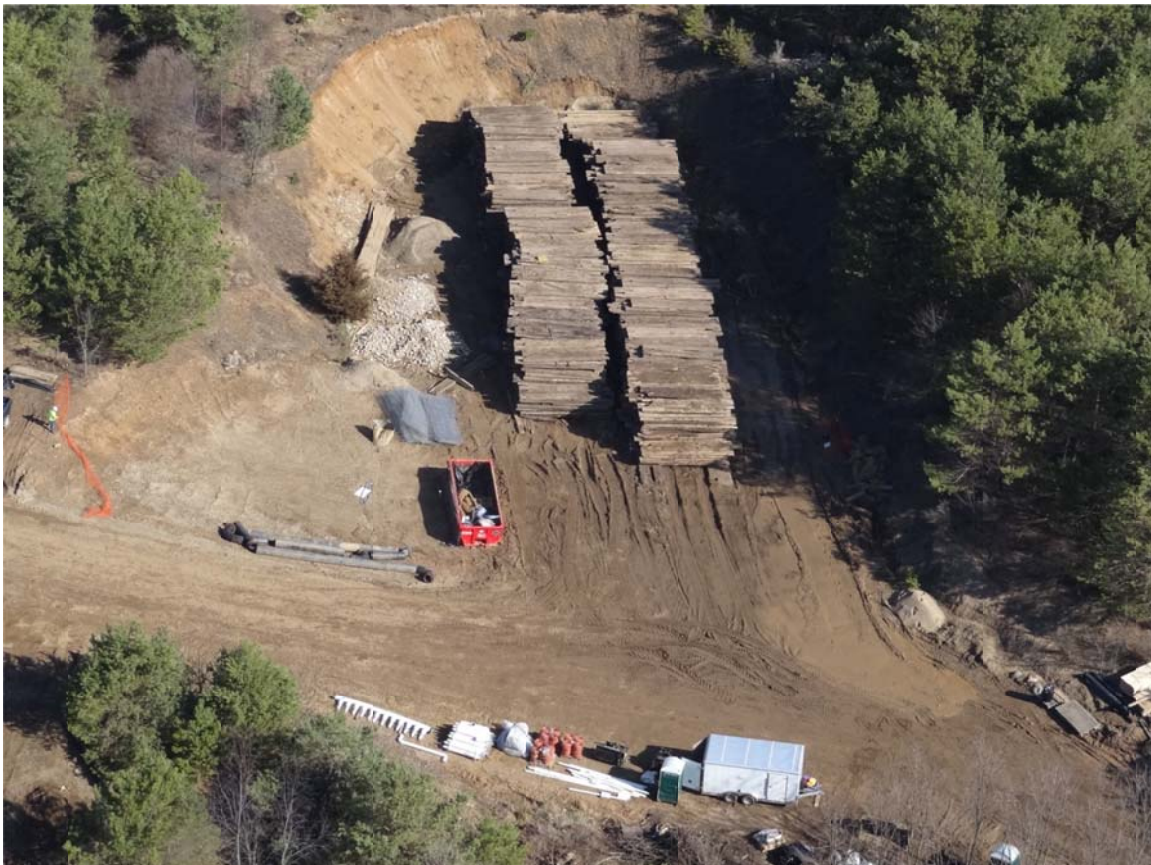
4. Timber mat staging area just west of 15-1/2 Mile Road.

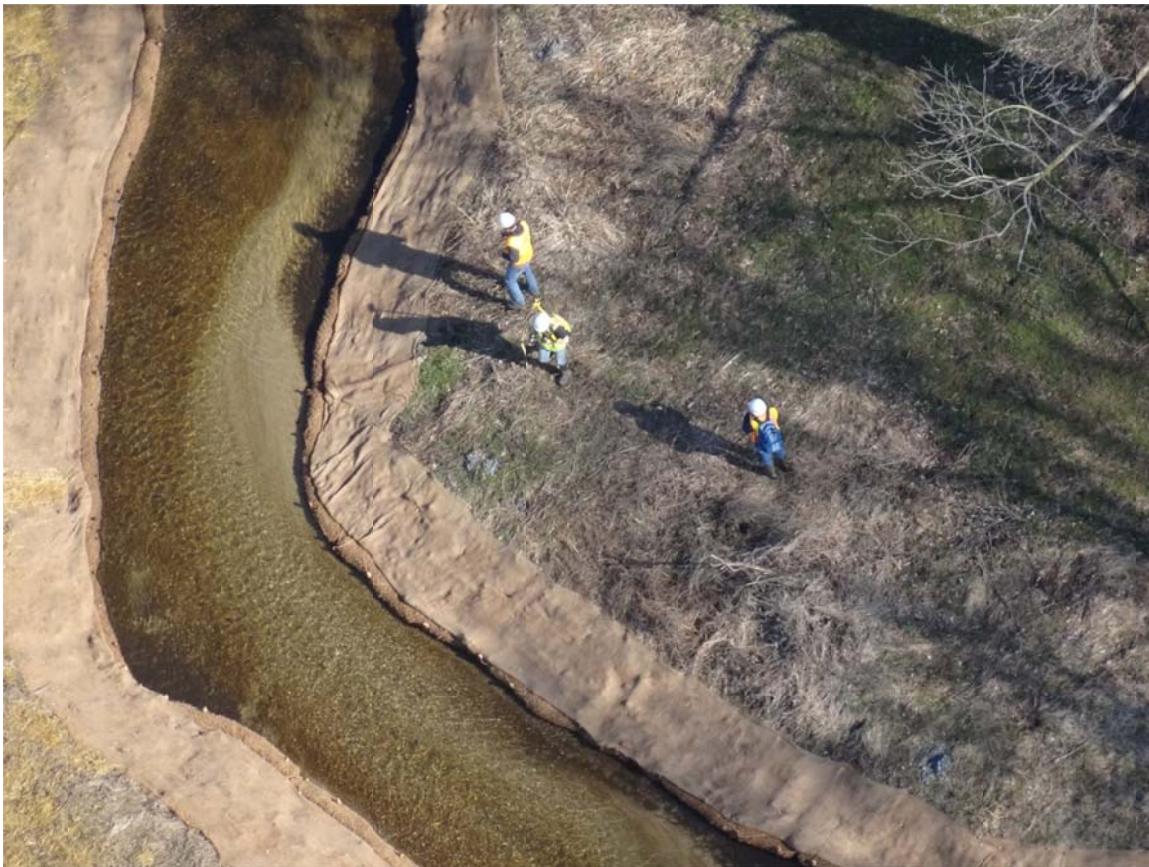
5. Survey crews on Talmadge Creek RDB near MP 1.75.

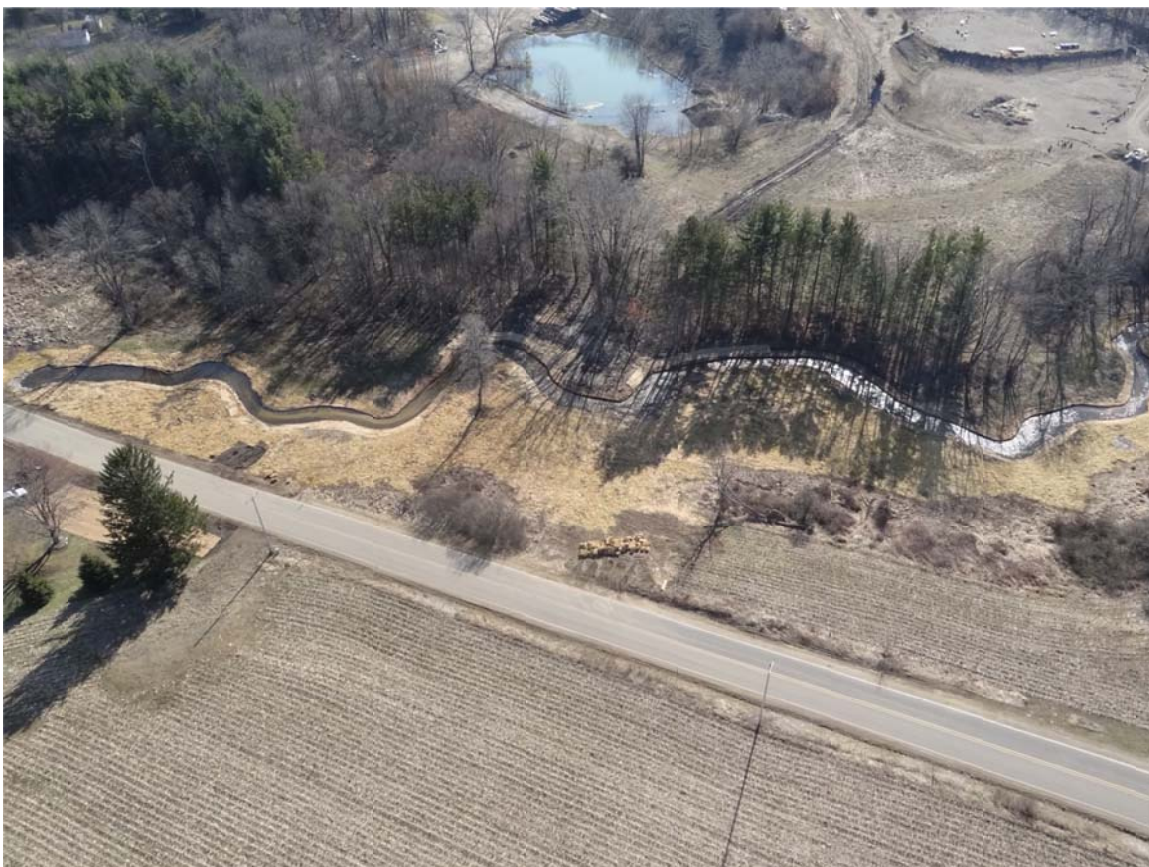
6. Completed restoration activities on Talmadge Creek from MP 1.75 to MP 2.00.

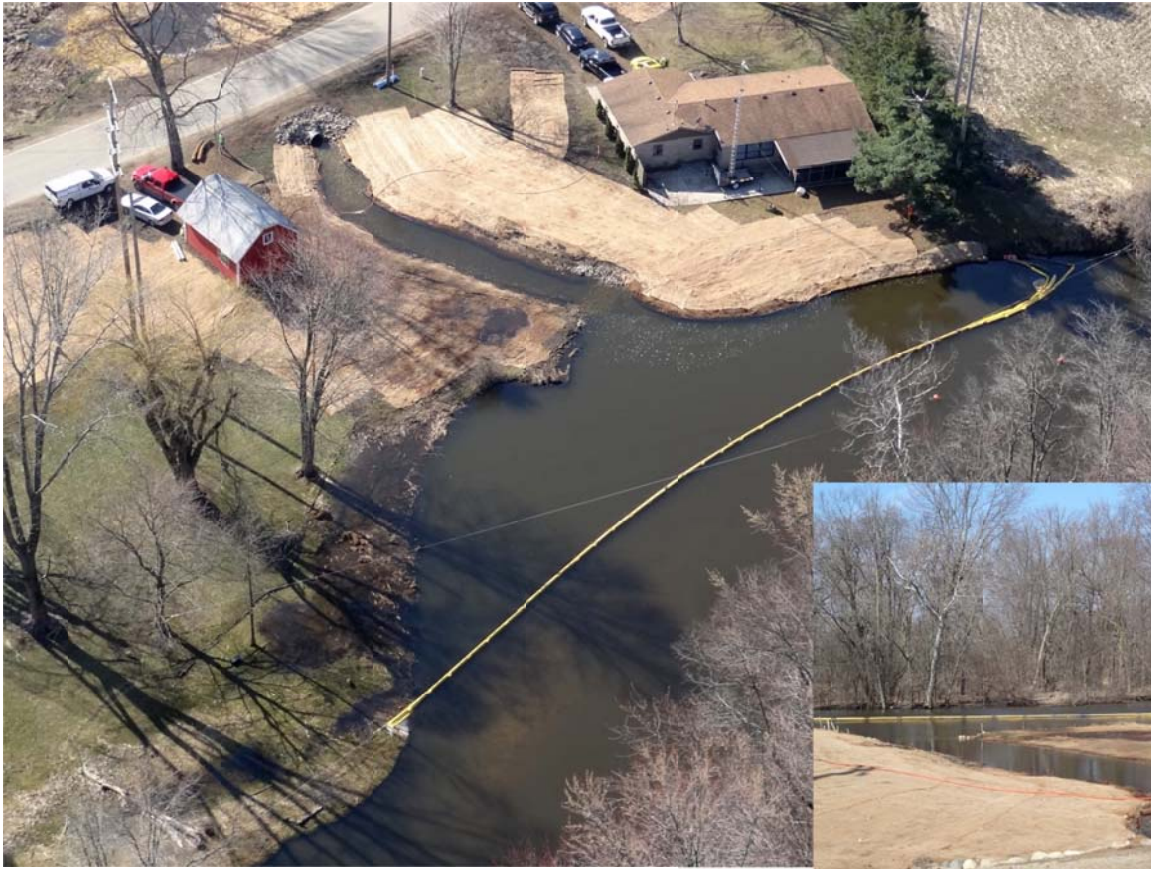
7. Confluence, no sheen or turbidity issues observed.

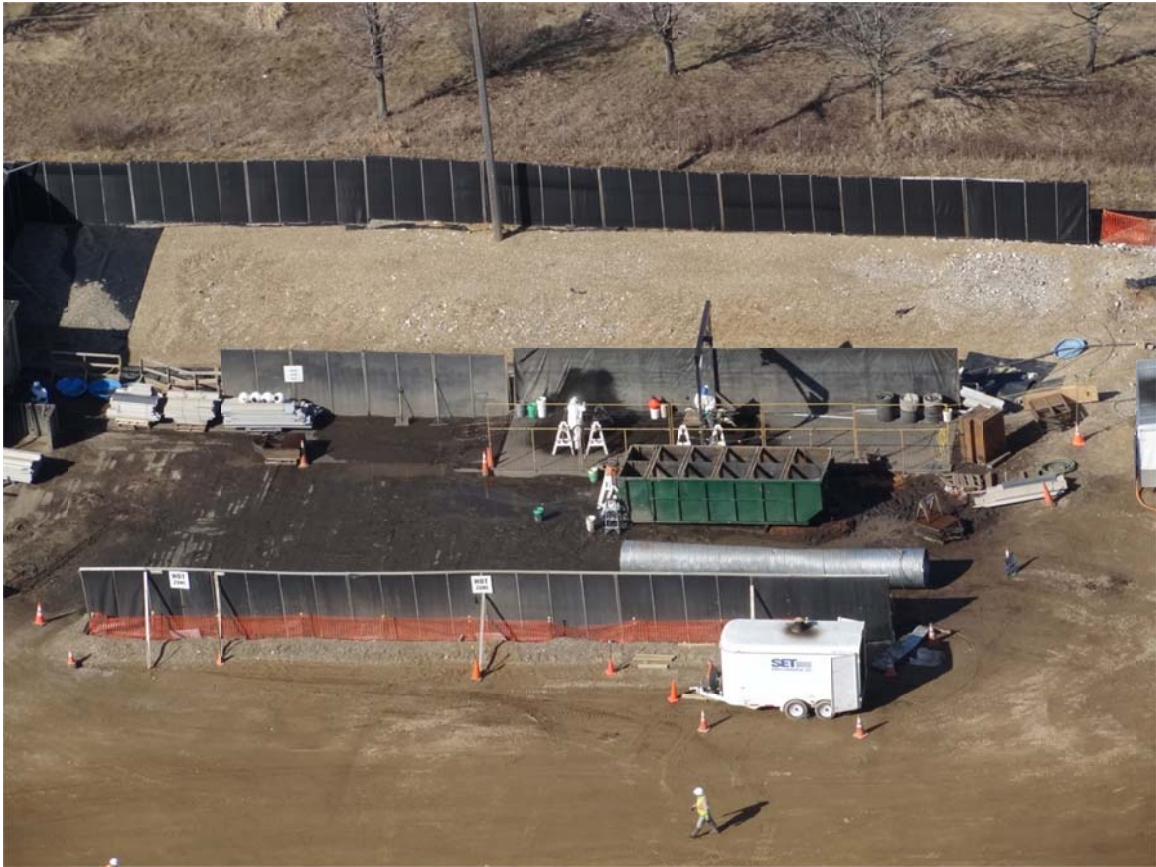
9. Frac-City, observed crews decontaminating sediment control box and culvert pipe.

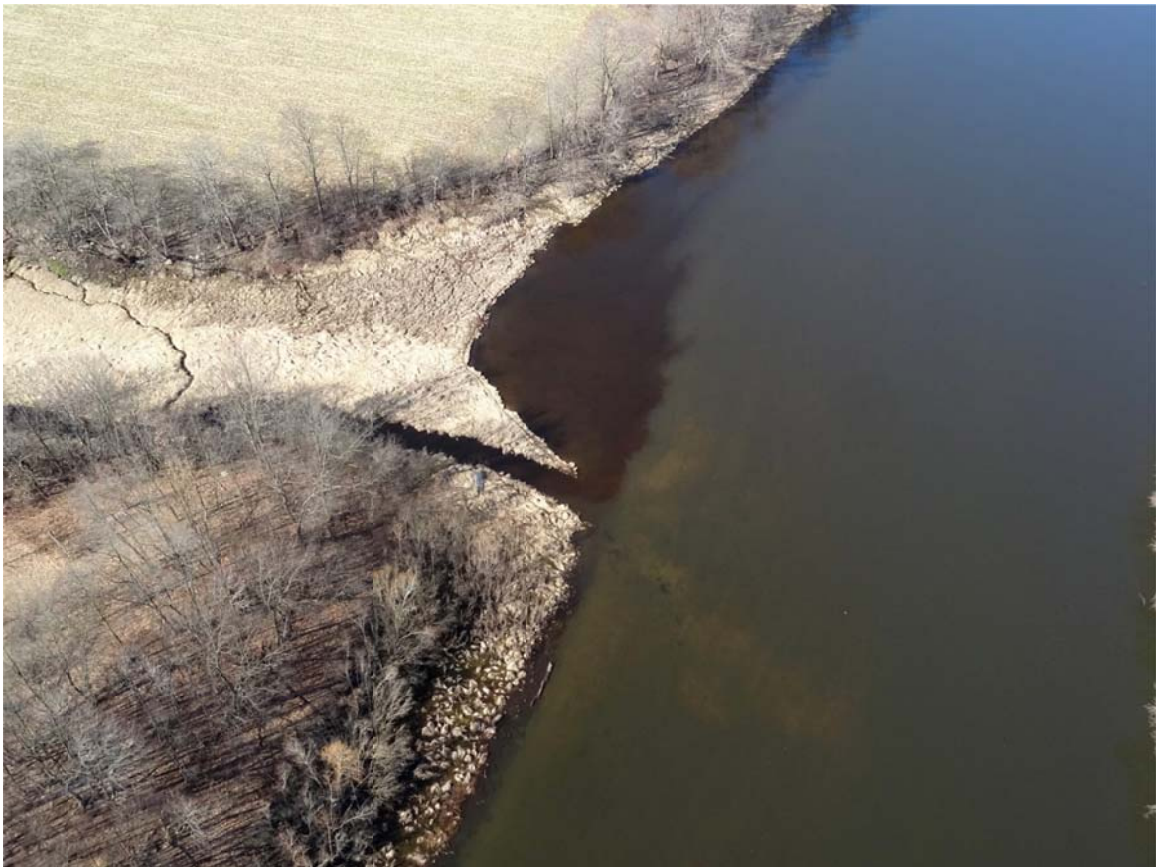
10. Former Lily Pad area, brown plume entering river from tributary on LDB.

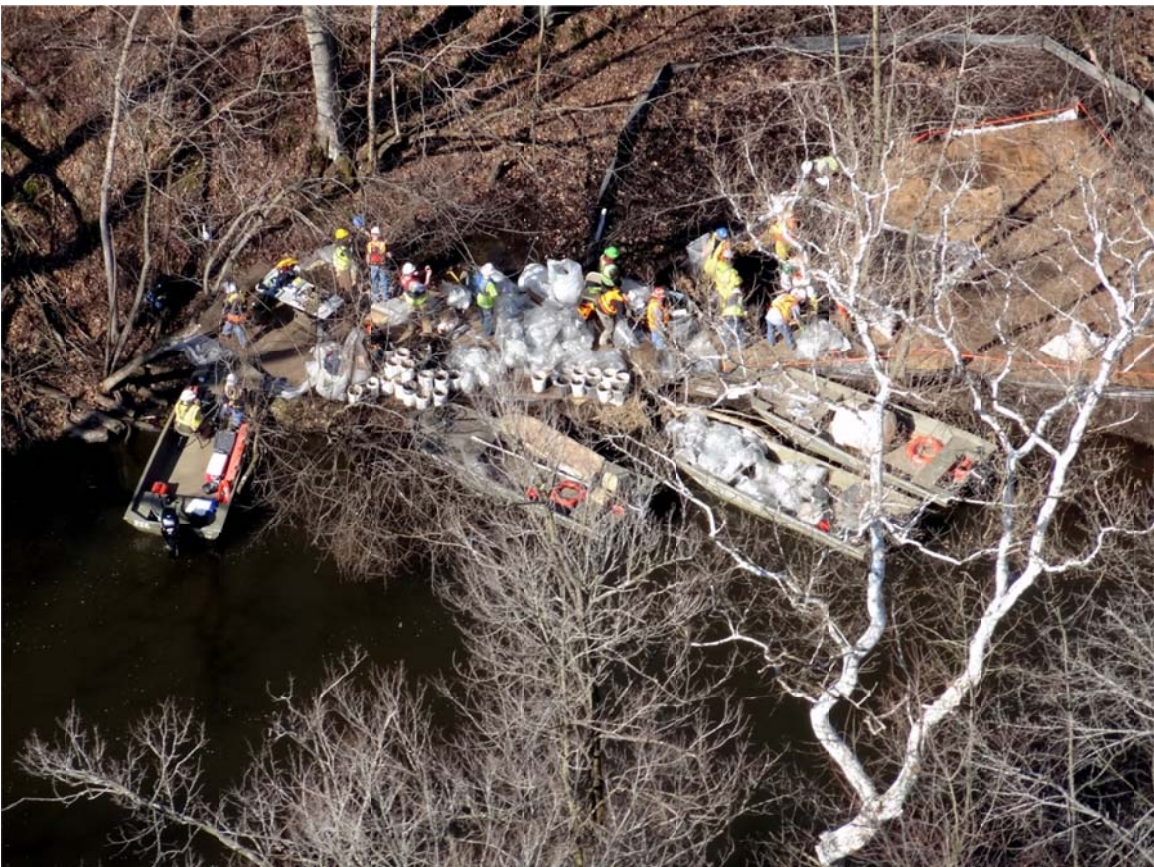
12. Scrape activities continue at OB 9.10 LDB.

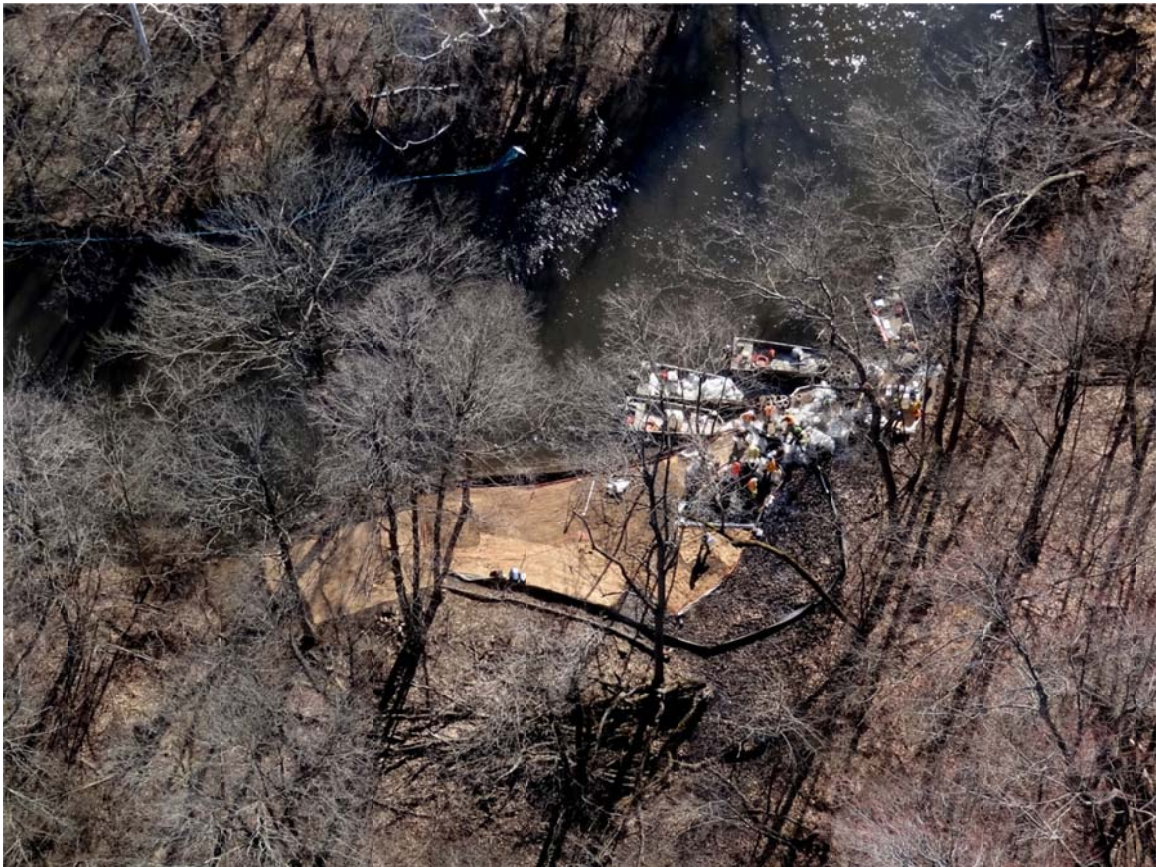
13. OB 9.10 LDB, scraping and restoration activities continue.

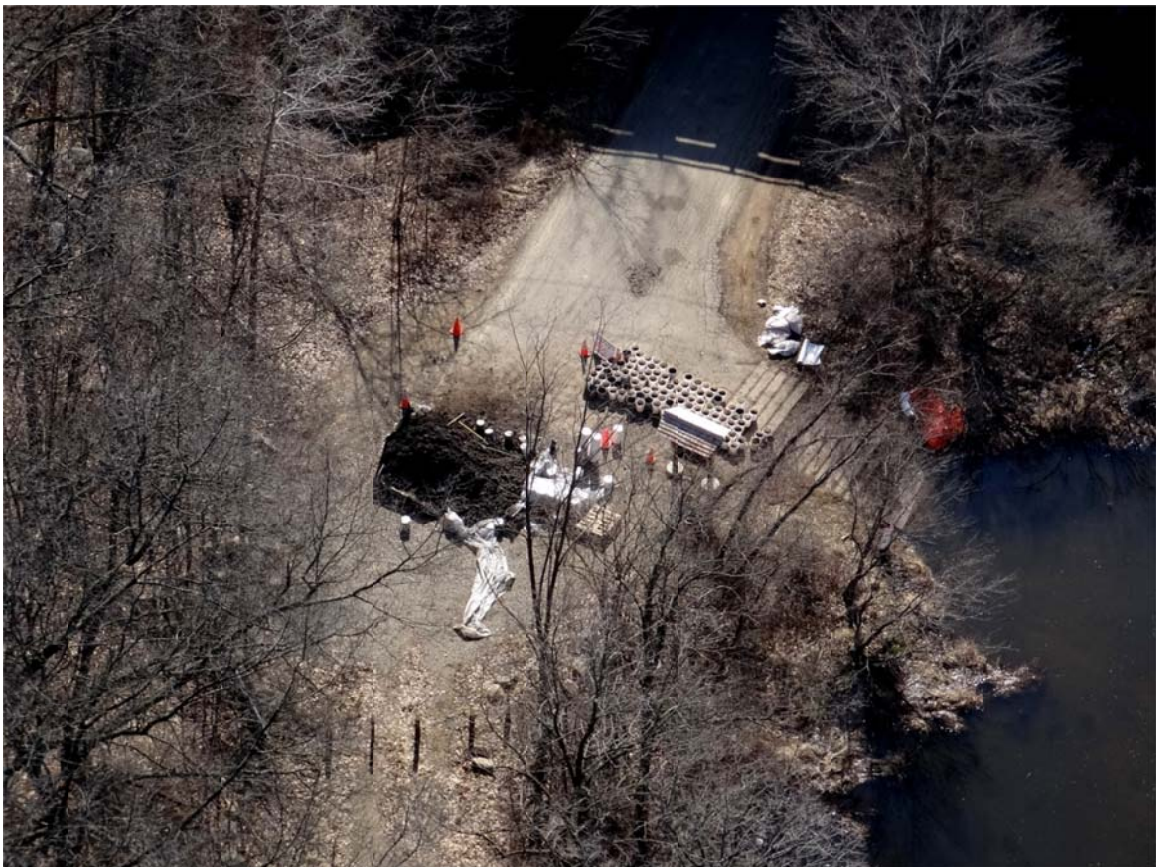
14. Boat ramp at Historic Bridge Park, soil staging area for OB 9.10 LDB scraping activities.

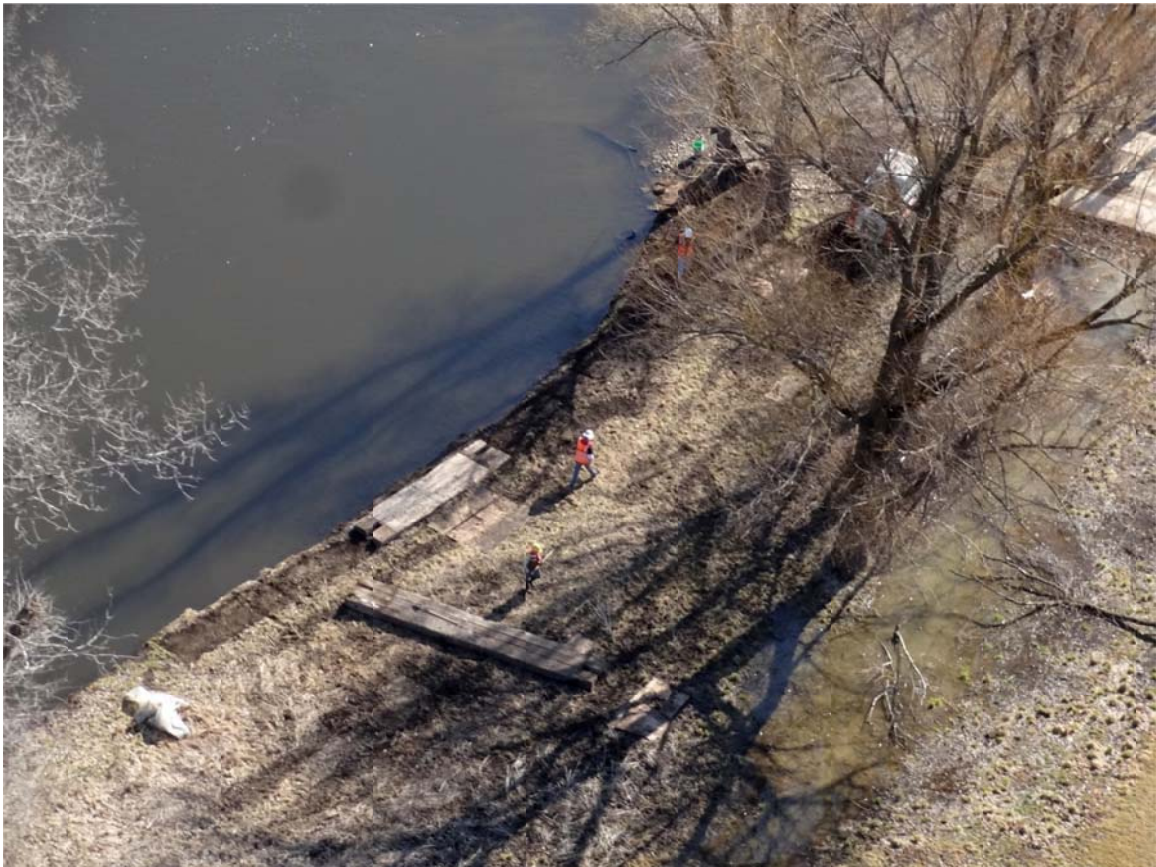
15. C3.2 Boat Launch, crews moving timber mats along shoreline.

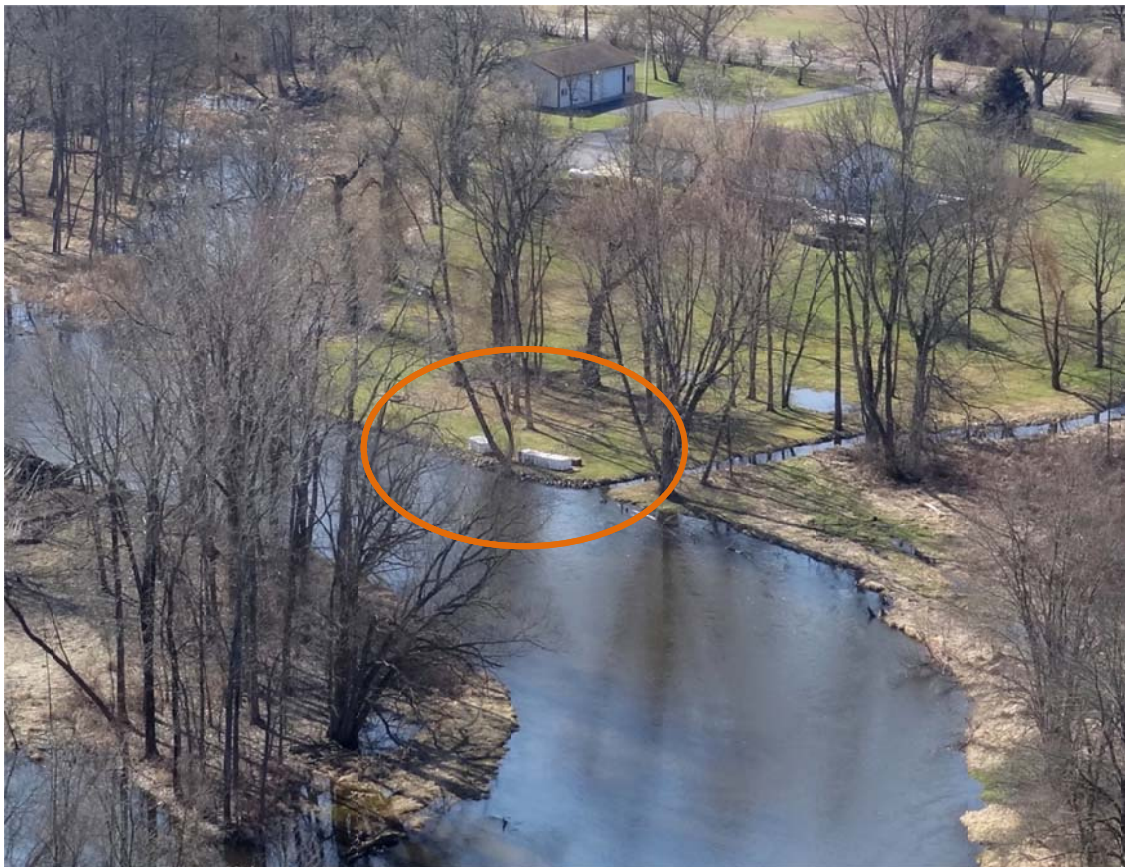
16. OB 10.37 RDB, materials staged across river from planned soil scraping location.

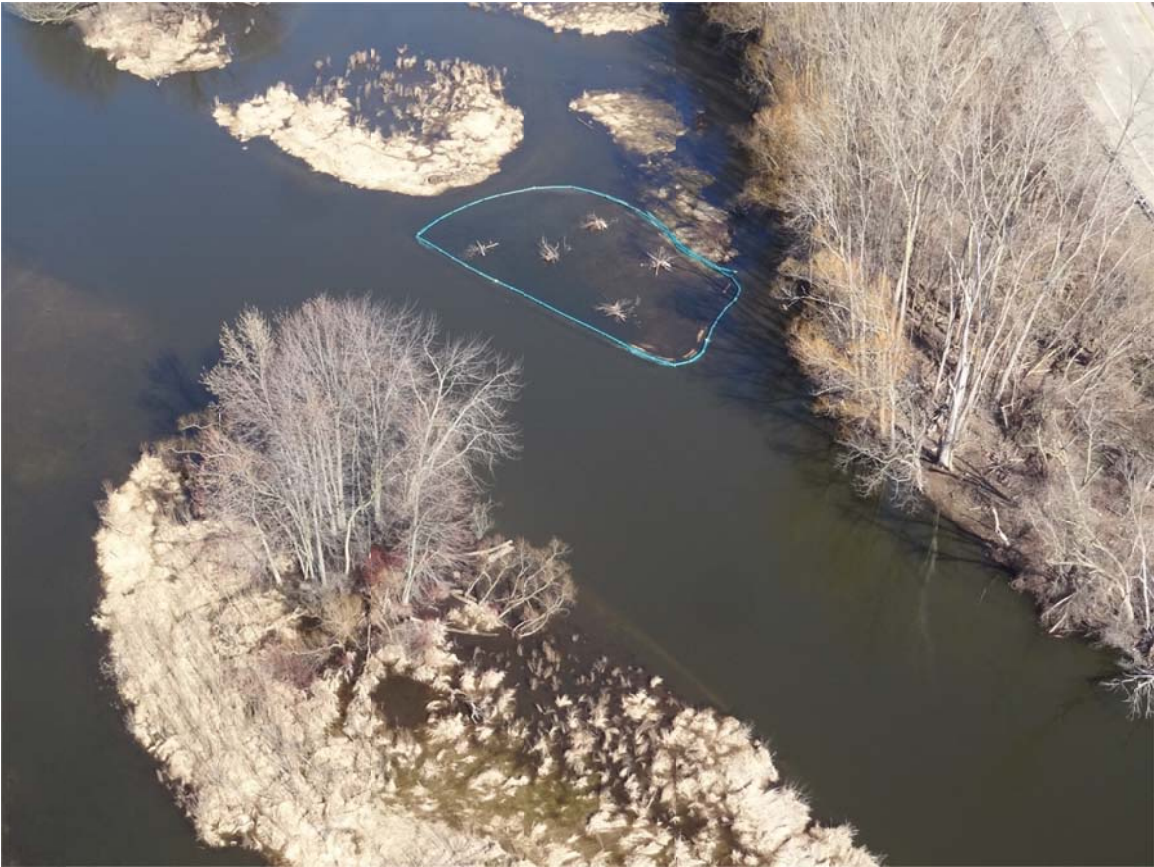
17. Former MP 14.97 Island, containment boom remains in place.

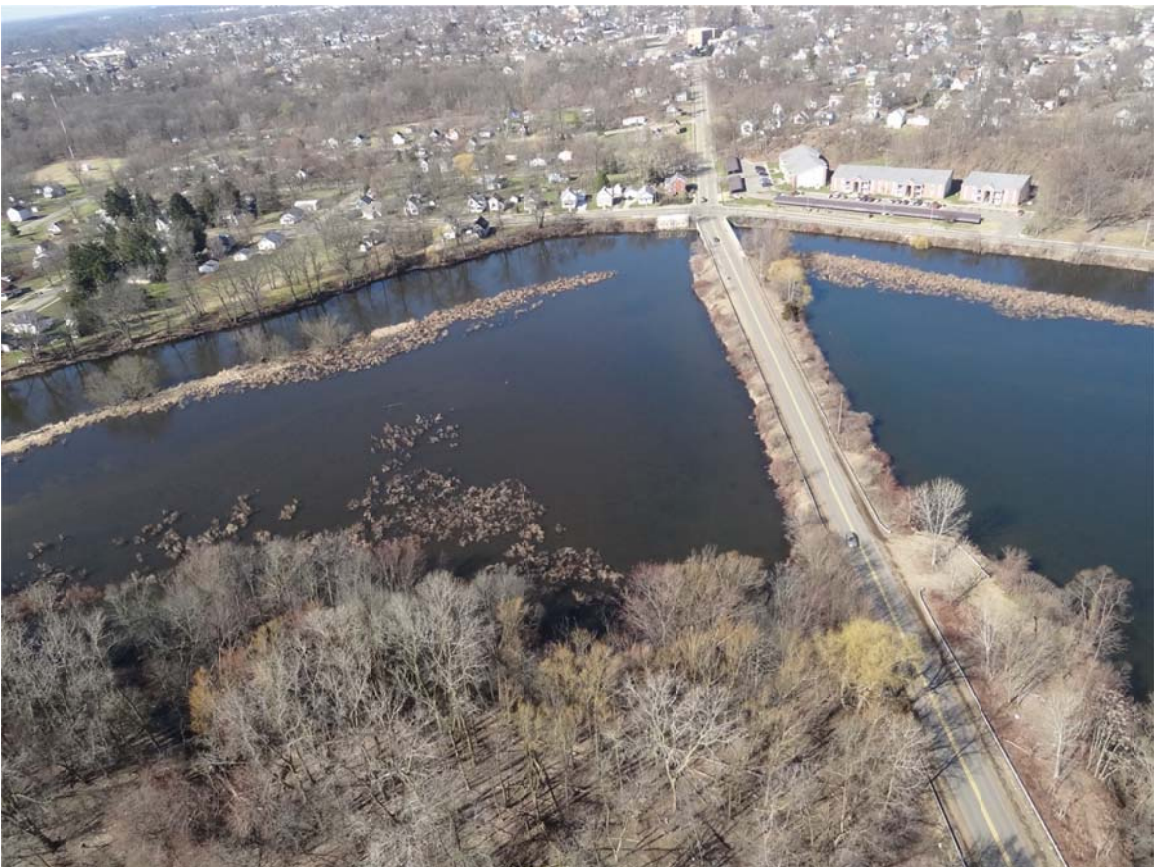
18. South Mill Pond, water levels appear elevated.

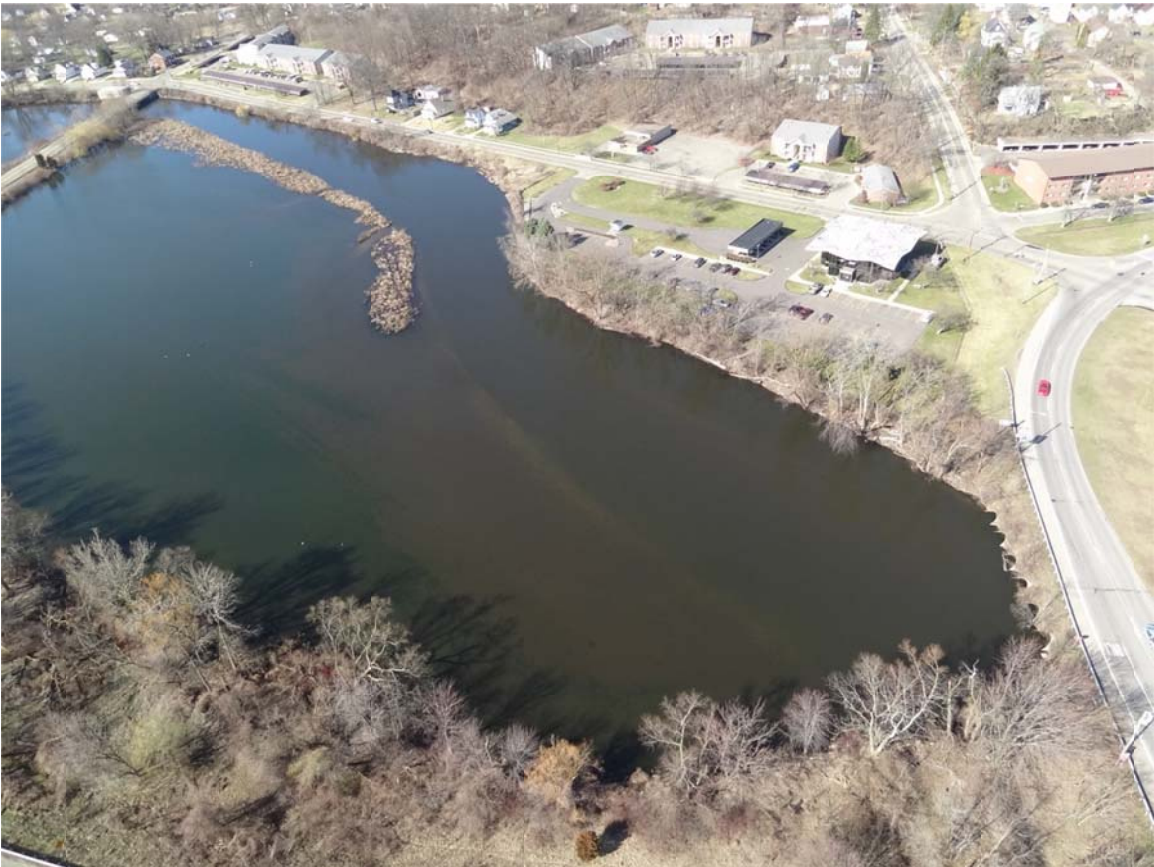
19. North Mill Pond, no sheen or turbidity issues observed.

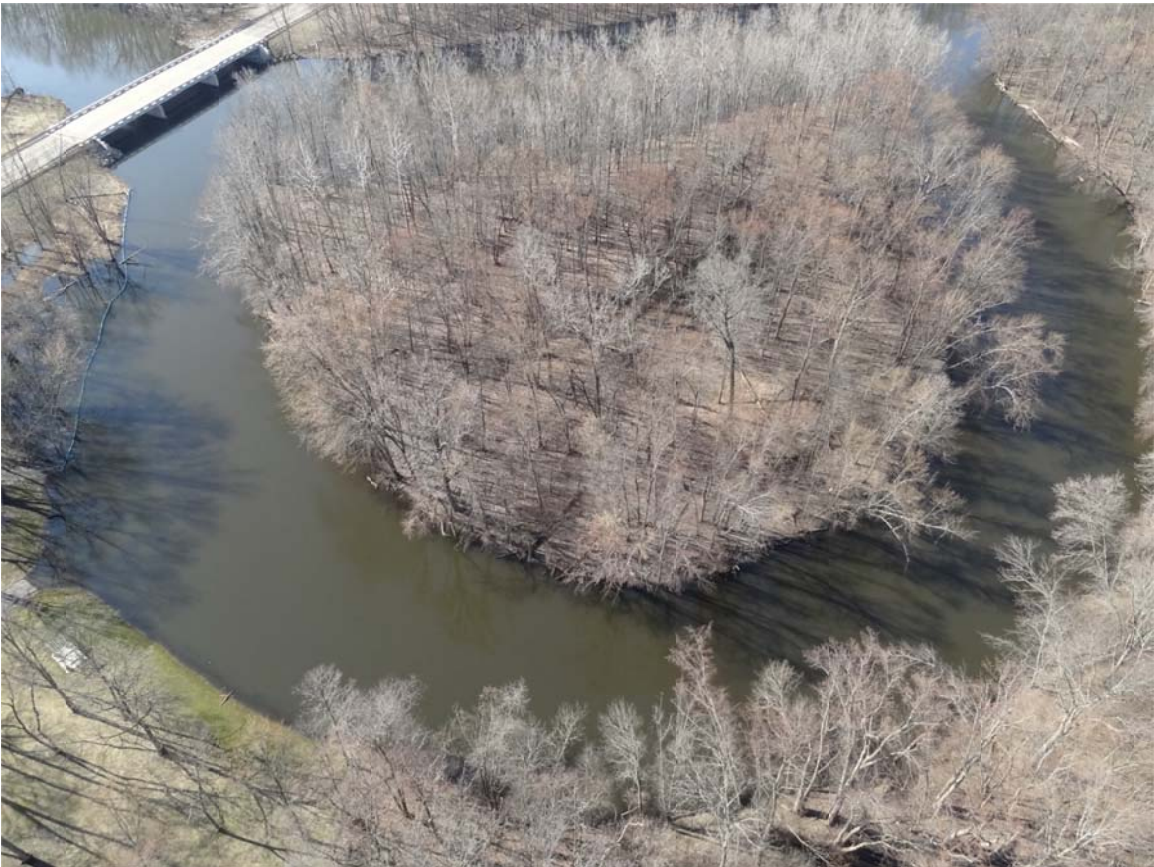
20. MP21.25 oxbow. No sheen or activity observed.

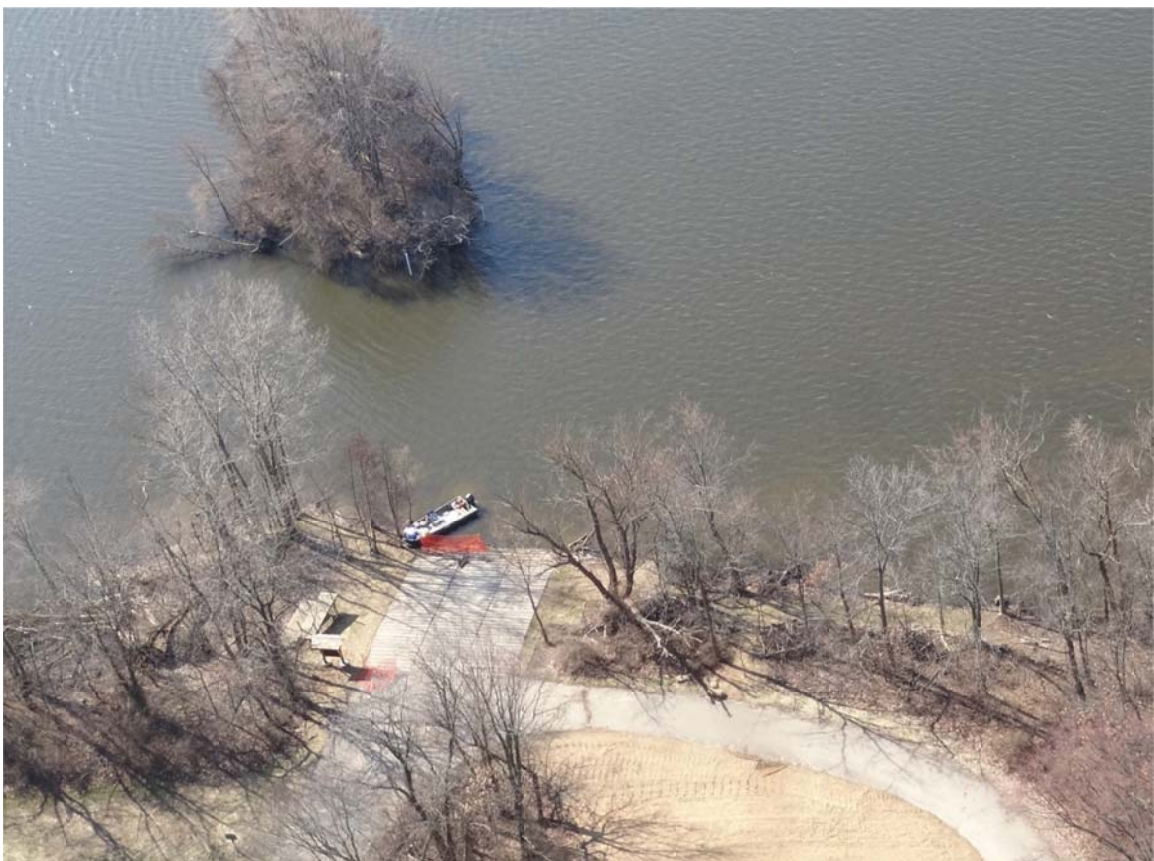
24. One boat staged at E4 boat launch on Morrow Lake.

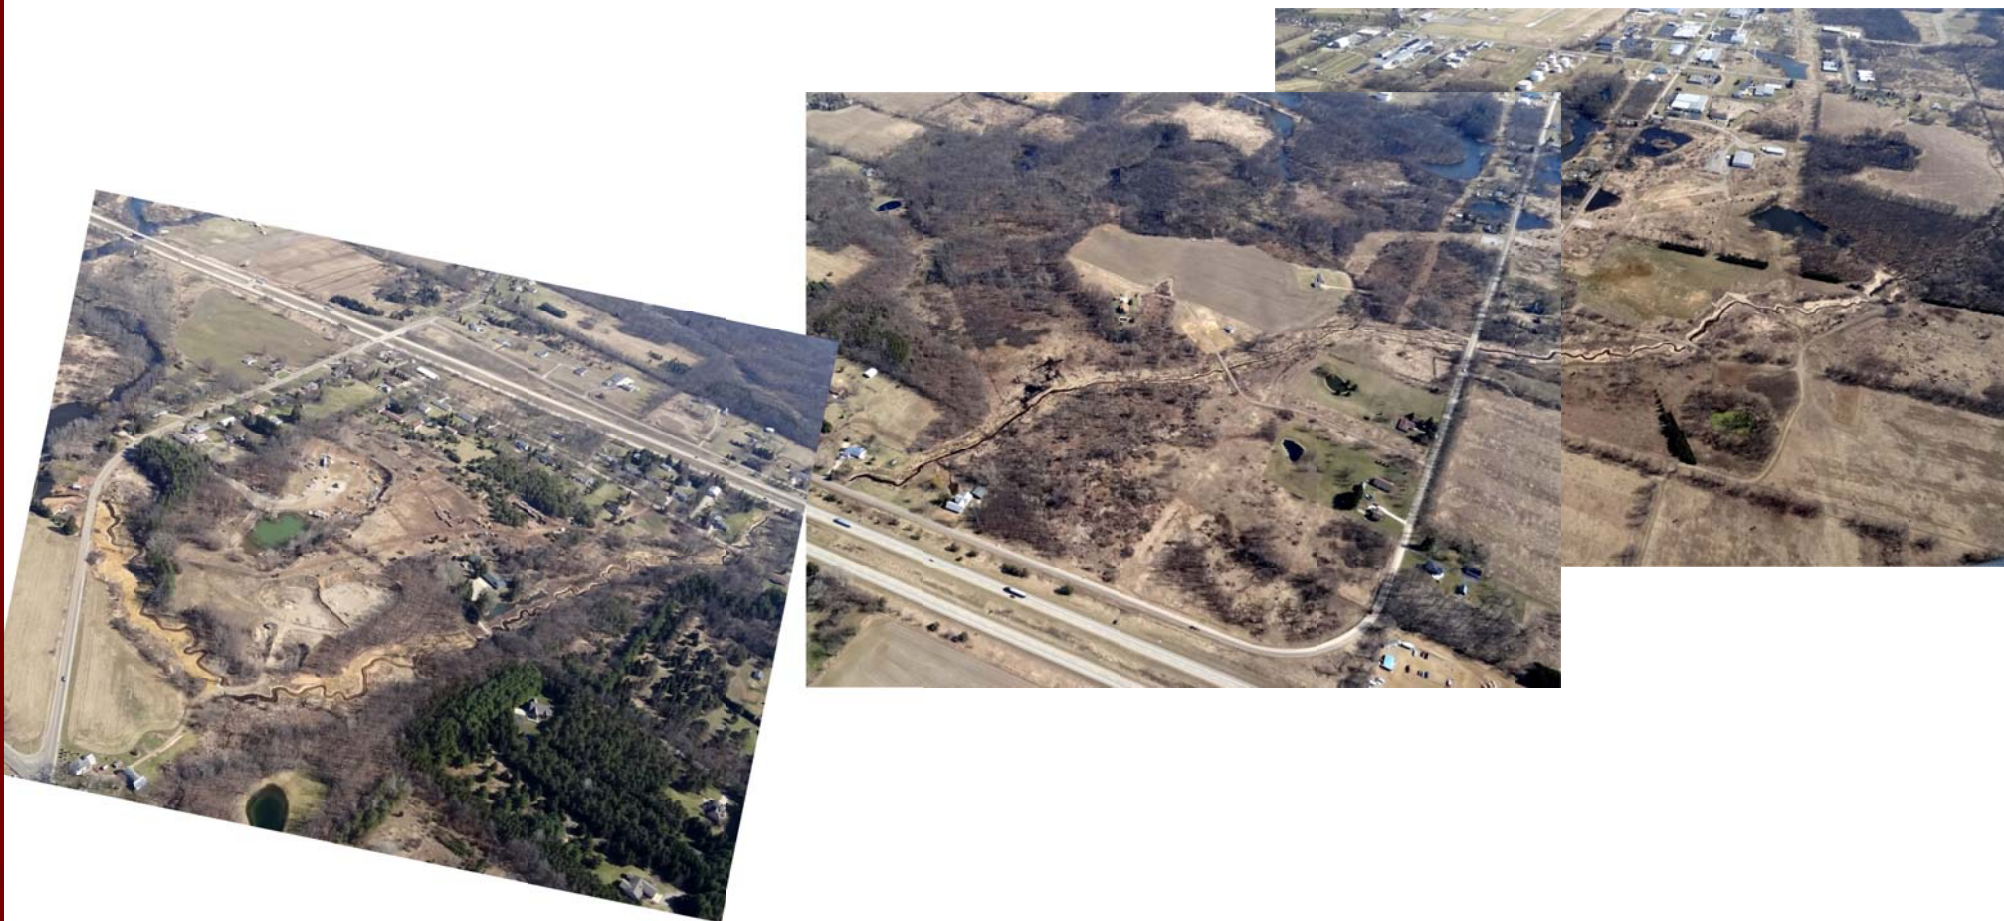
27. High altitude panoramic view of Talmadge Creek from Release Point to Confluence. No "yellow iron" observed along creek for entire 2-mile stretch.
